HISTORIC STRUCTURE REPORT

Schooner *C.A. Thayer*

National Park Service | June 2022

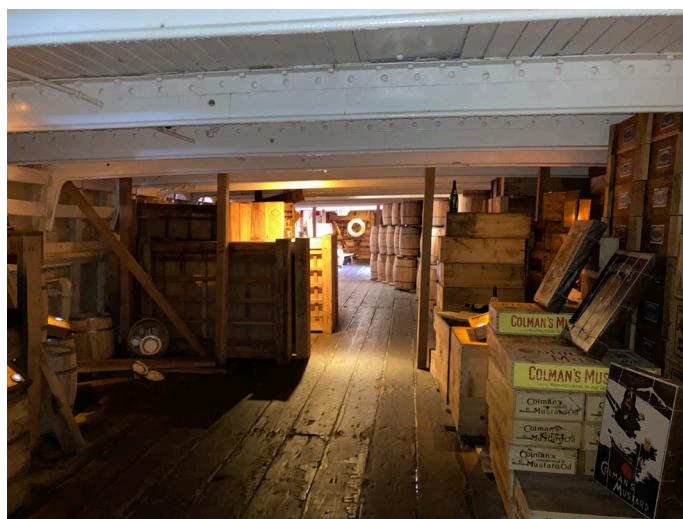
Photo 2: The hold on the adjacent Balclutha has a different situation where simulated cargo displays pose a higher quantity of readily ignitable fuels that could result in relatively fast fire spread throughout the vessel. If a similar display arrangement is eventually placed on the Thayer, then the fire threat to the vessel will significantly increase.

Managing the fire risk to prevent fire ignition is the single most important component of the Thayer fire protection program and the following fire prevention measures are recommended:
